TEST REPORT

CRASHWORTHINESS TESTING
OF AEV TRAMAHAWK TYPE III AMBULANCE

AMERICAN EMERGENCY VEHICLES

GENERAL TESTING LABORATORIES, INC.
1623 LEEDSTOWN ROAD
COLONIAL BEACH, VIRGINIA 22443

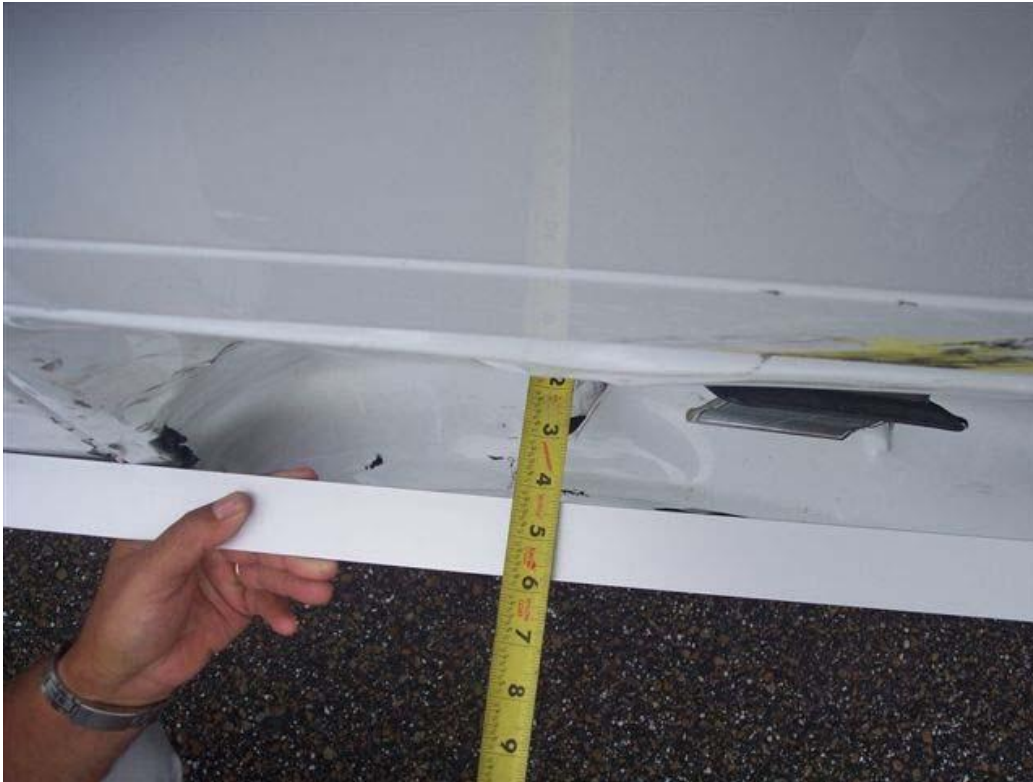
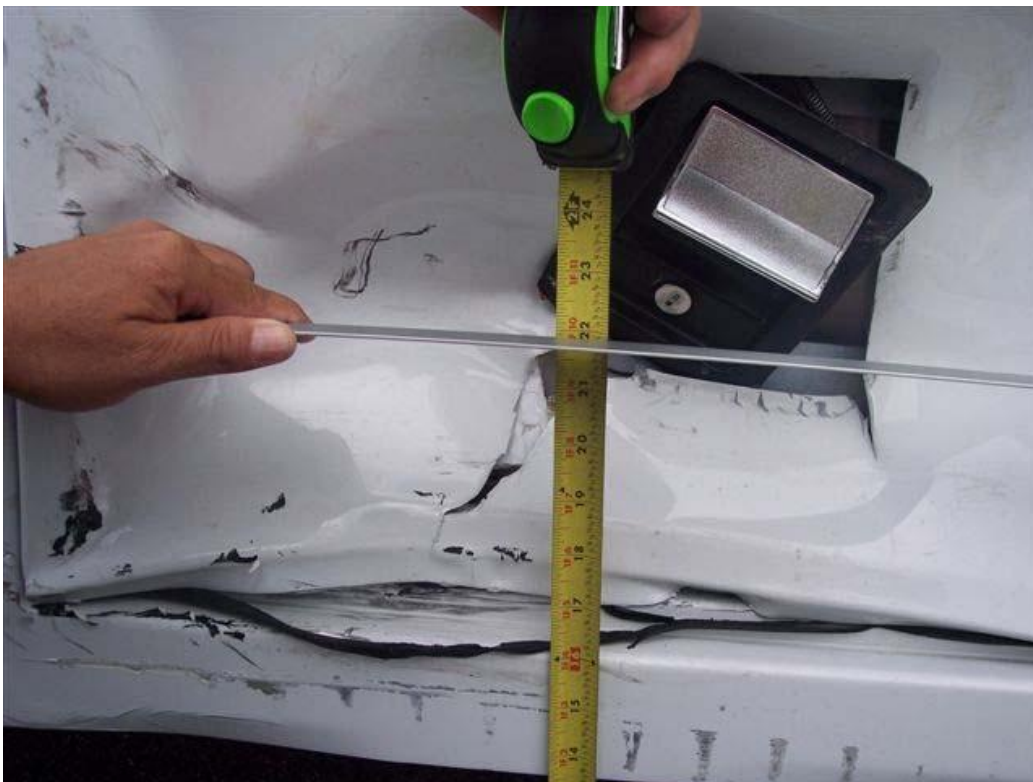
TEST #	AMBULANCE DEFORMATION		
	LOCATION	DISTANCE FROM GROUND	STATIC CRUSH
GTL052	RIGHT SIDE BATTERY COMPARTMENT	21 7/8"	4 1/4"
GTL055	LEFT SIDE STORAGE COMPARTMENT	23 3/4"	2 5/16"

RIGHT SIDE IMPACT SHOWING MEASUREMENT OF MAXIMUM CRUSH (TEST #052)

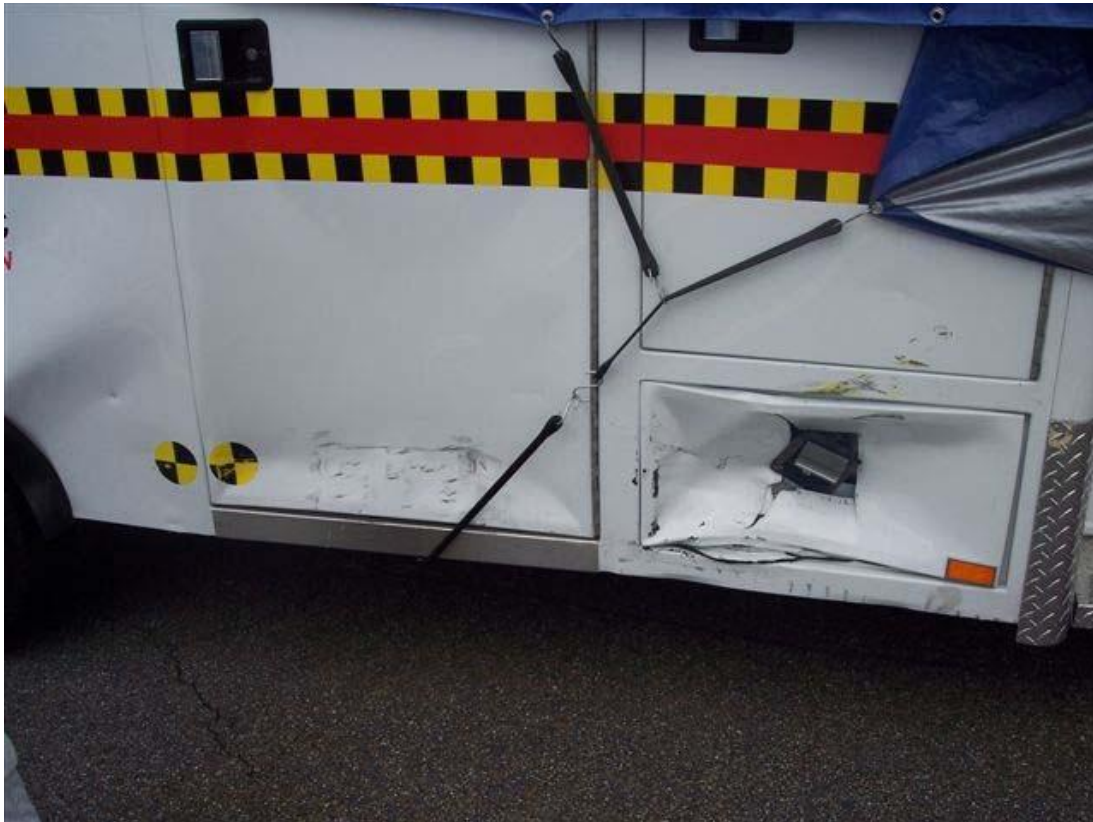
The battery compartment was bent in and the latch was destroyed. The left side lower storage compartment doors were bent in. The storage compartment floor and framing was distorted.

OVERALL VIEW OF RIGHT SIDE SHOWING DAMAGE TO PERSONNEL DOOR AND BATTERY COMPARTMENT (TEST 052)

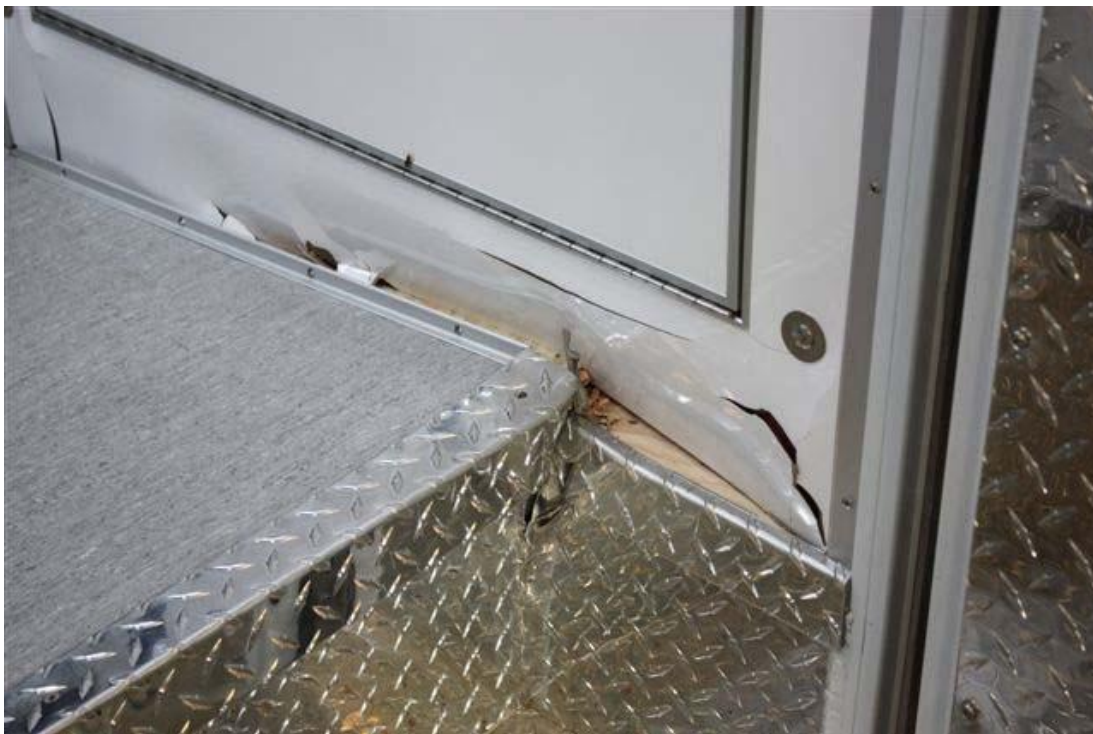
There was some minor separation and bending along the joint between the floor and wall behind the hinge side of the patient compartment door.

VIEW SHOWING DAMAGE INSIDE PERSONNEL DOOR (TEST 052)

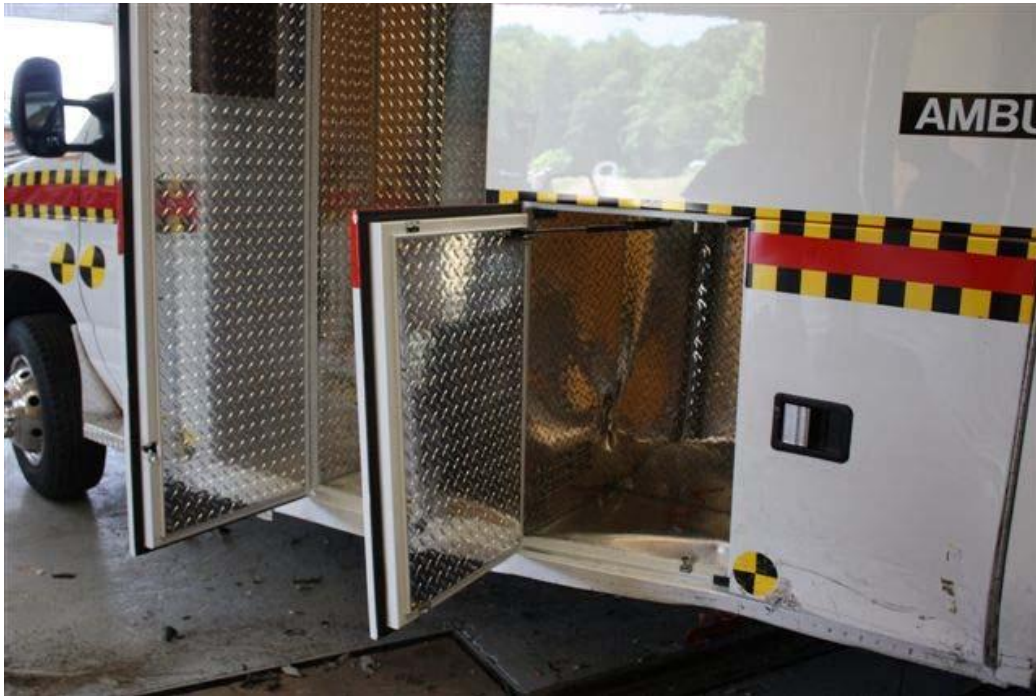
**VIEW SHOWING DAMAGE TO INTERIOR OF LEFT SIDE
STORAGE COMPARTMENT (TEST 055)**

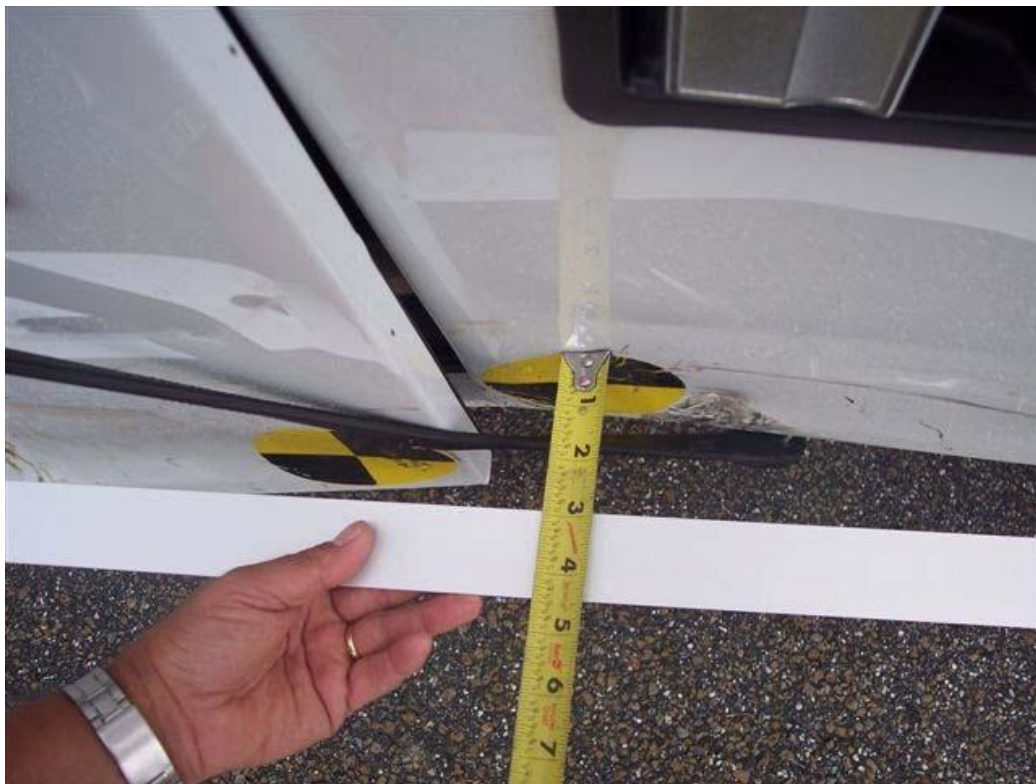
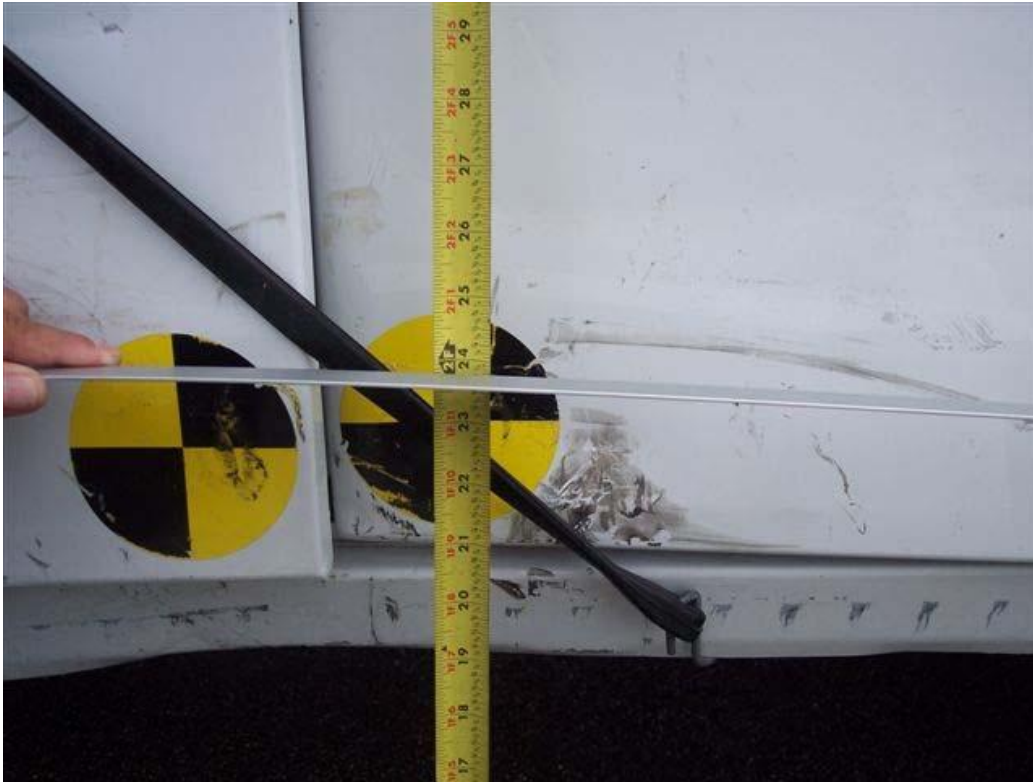
LEFT SIDE IMPACT SHOWING MEASUREMENT OF MAXIMUM CRUSH (TEST #055)

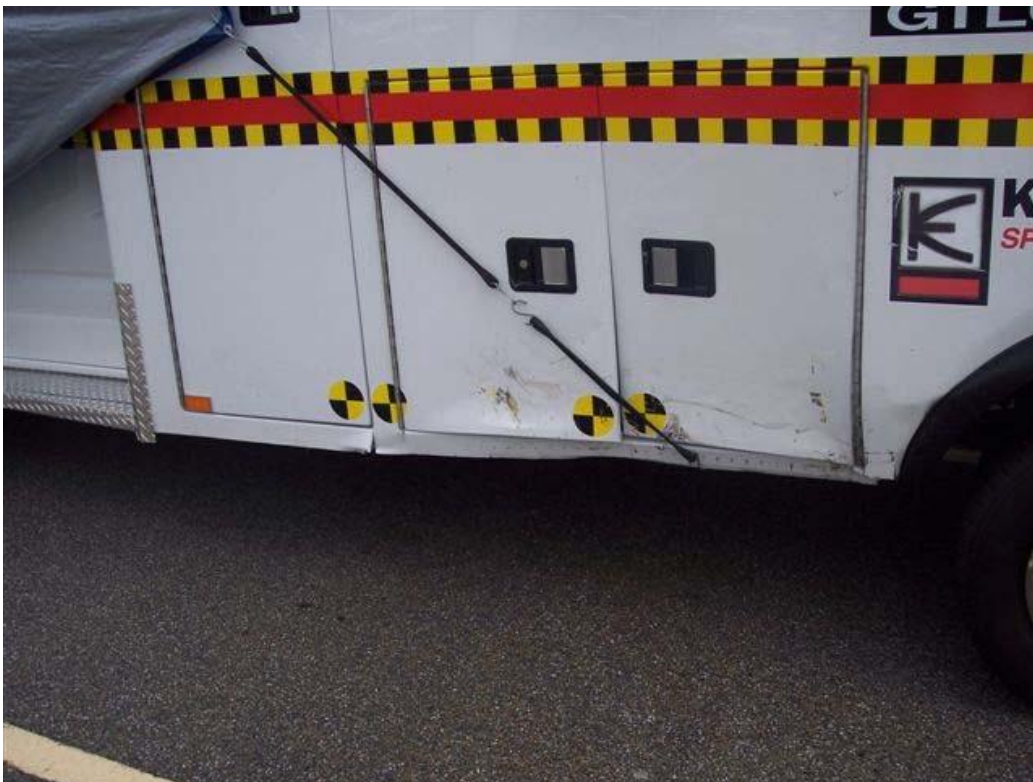
OVERALL VIEW OF LEFT SIDE DAMAGE (TEST #055)
