**GILLIG HEAVY DUTY TRANSIT BUS  
40' LOW FLOOR DIESEL \*BRT PLUS\***

**JEFFERSON PARISH, LOUISIANA  
INVITATION TO BID  
BID NO.: 50-00145018 - JUNE 4, 2024**

**RE: IFB NO.: 50-00145018, FIVE (5) YEAR CONTRACT TO PROVIDE AND DELIVER ONE (1) – TEN (10) HEAVY DUTY TRANSIT BUSES**

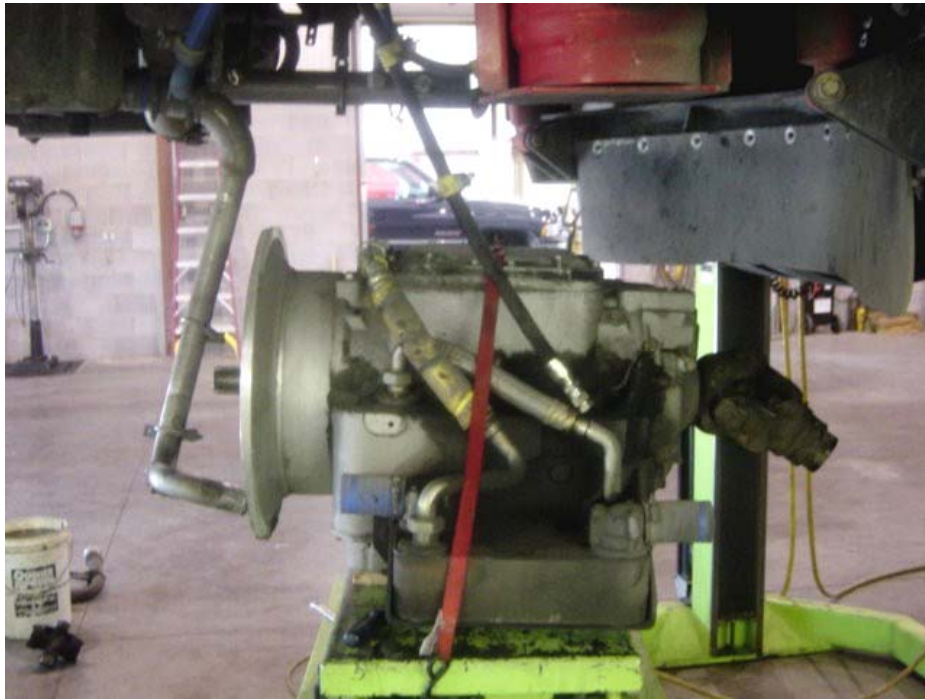
**TRANSMISSION REMOVAL AND REPLACEMENT  
(8.00 MAN HOURS)**

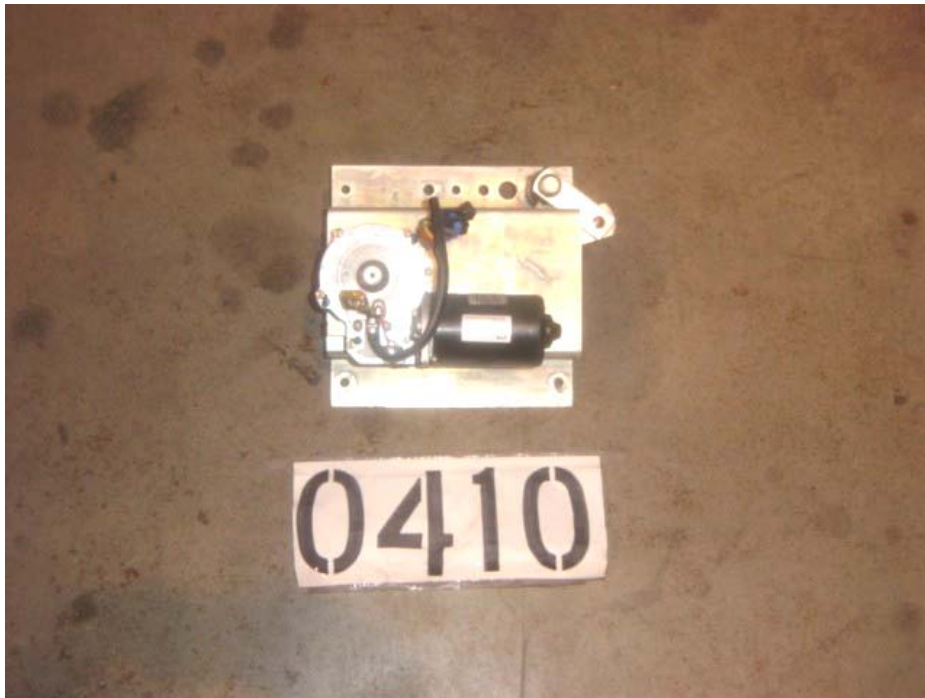
**WIPER MOTOR REMOVAL AND REPLACEMENT  
(0.50 MAN HOURS)**

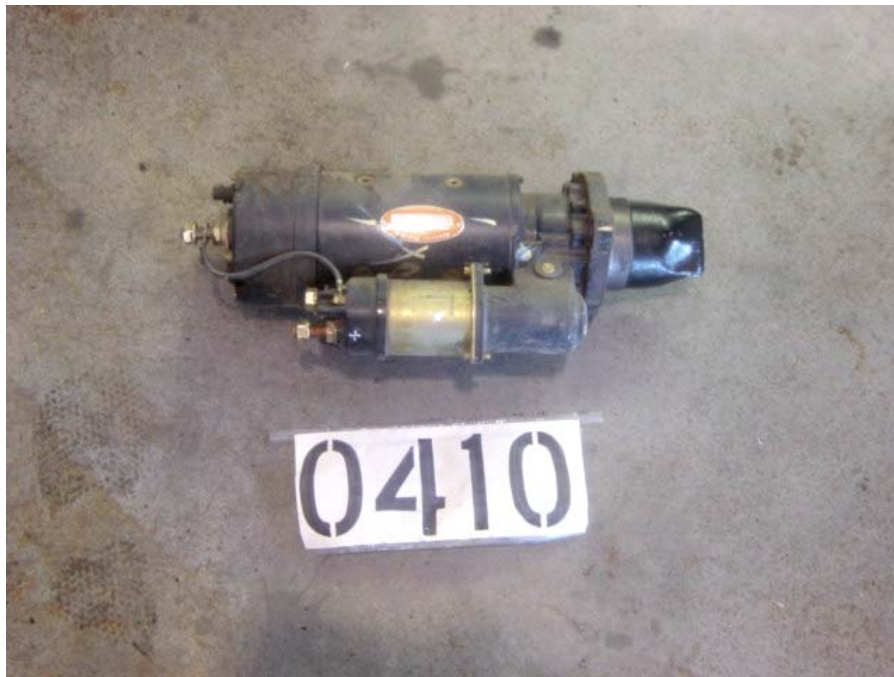
#### **STARTER REMOVAL AND REPLACEMENT (0.75 MAN HOURS)**

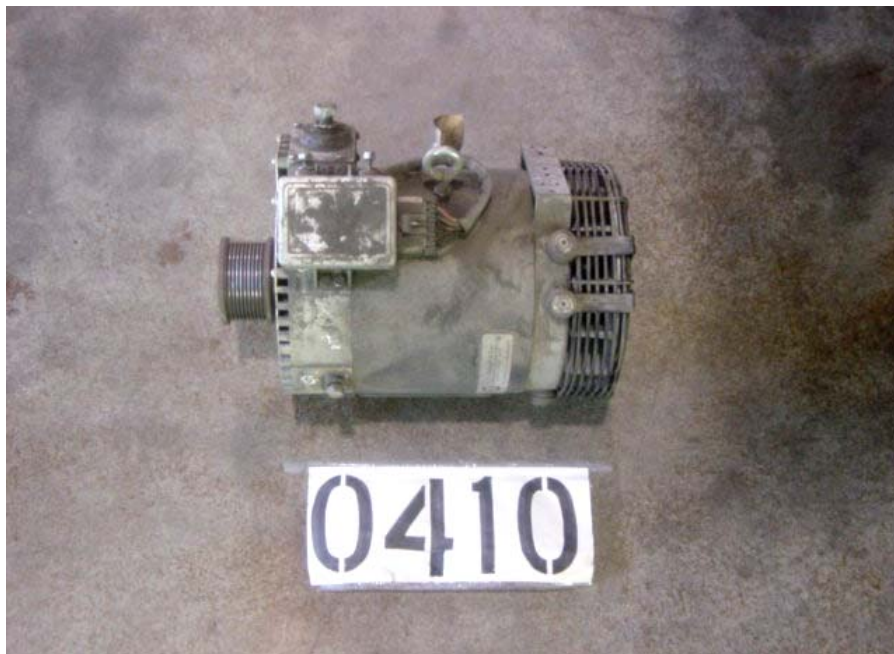
#### **ALTERNATOR REMOVAL AND REPLACEMENT (0.75 MAN HOURS)**

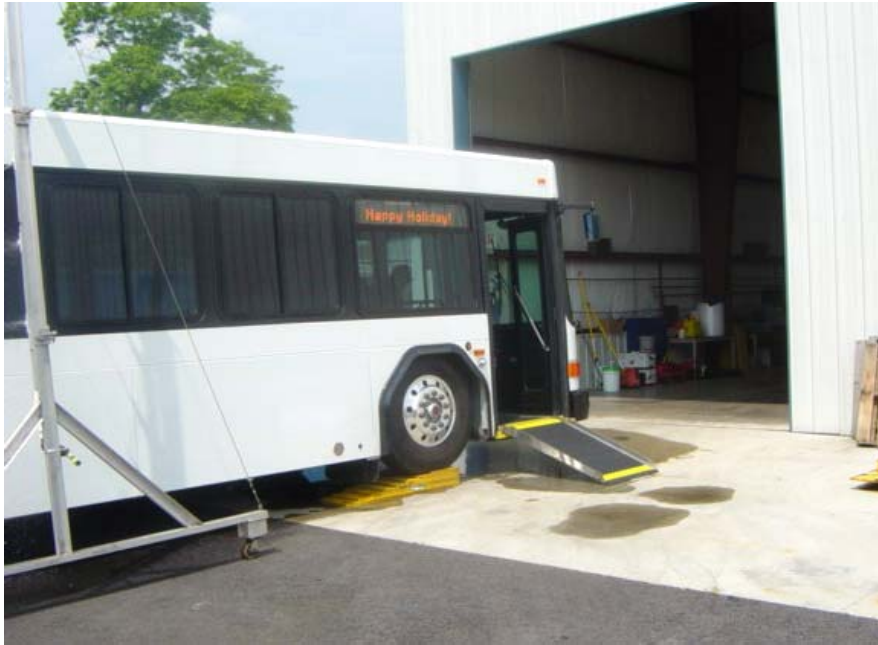
**RIGHT FRONT WHEEL SIX INCHES HIGHER**

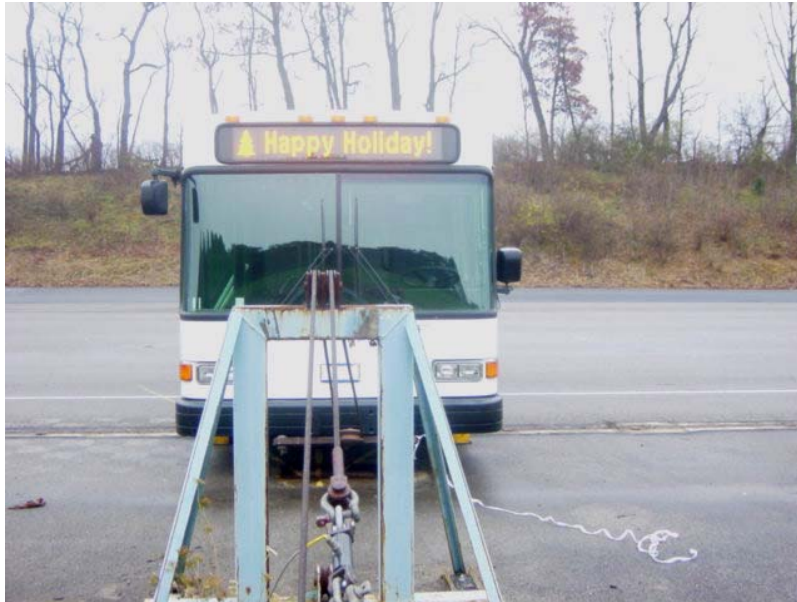
### FRONT 20° UPWARD PULL

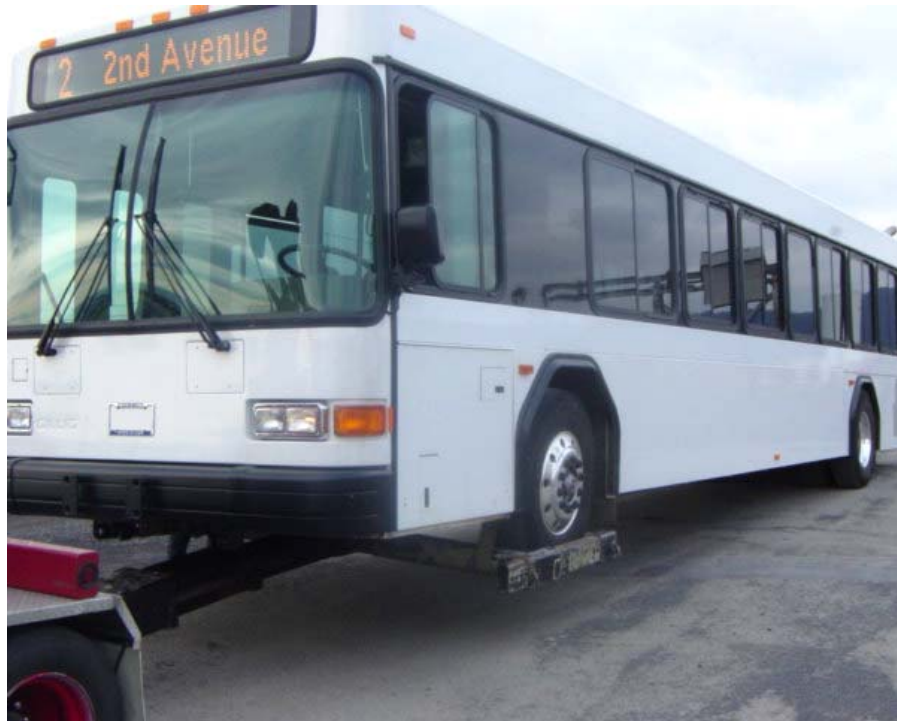
**TOWING INTERFACE**

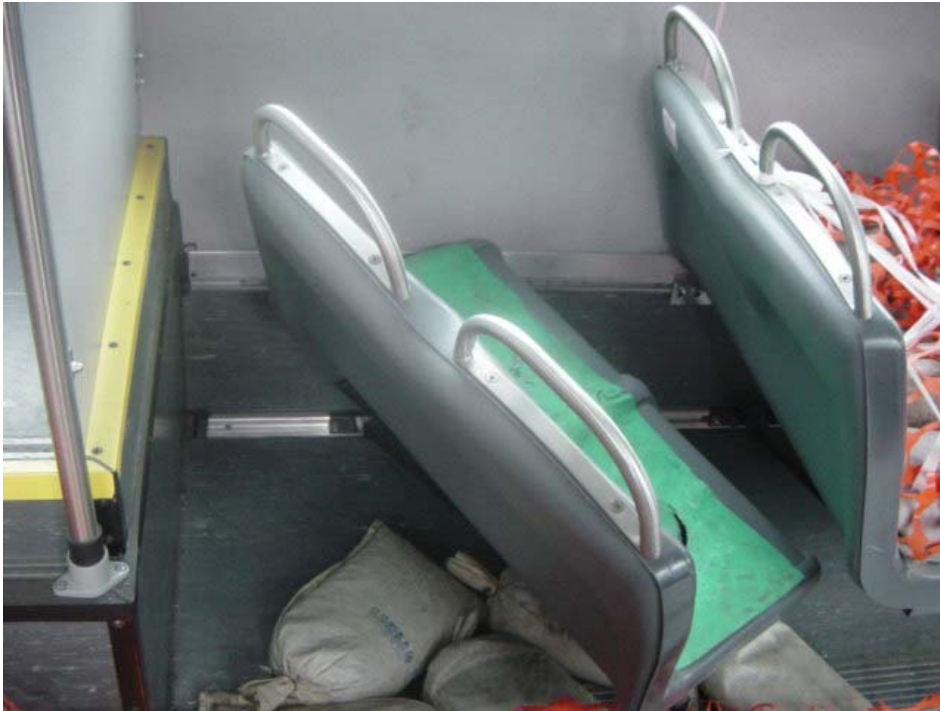
**BROKEN SEAT FRAME  
(5,500 TEST MILES)**

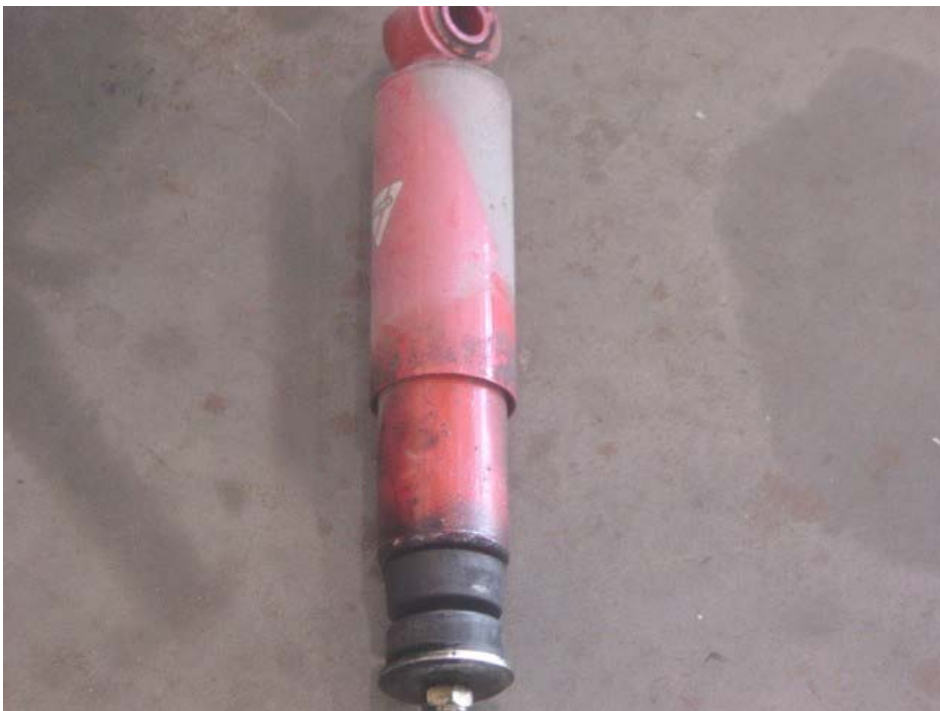
**BROKEN LEFT FRONT SHOCK  
(9,974 TEST MILES)**

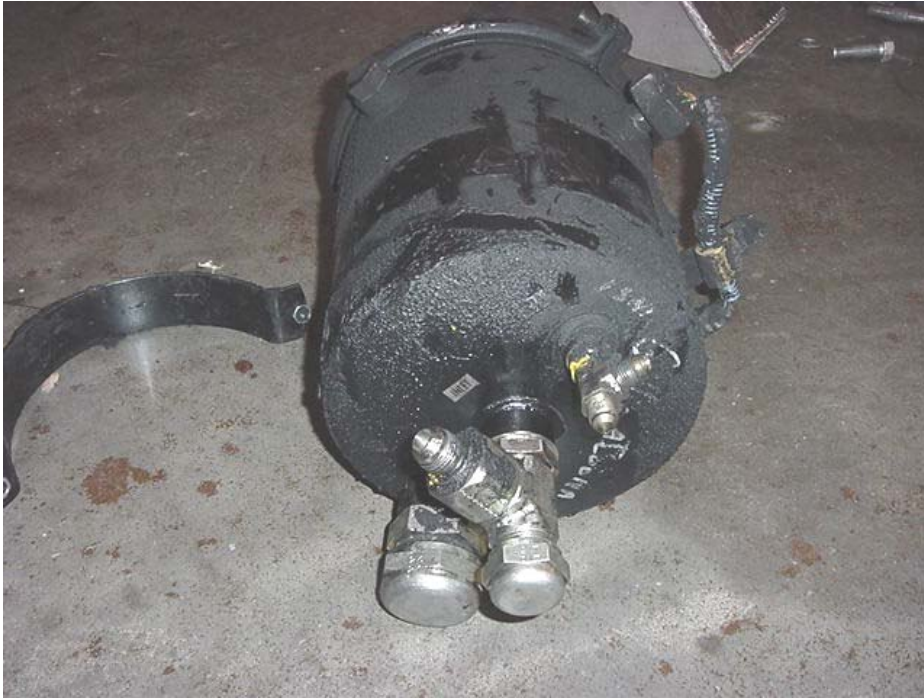
**CRACKED HYDRAULIC RESERVOIR  
(12,487 TEST MILES)**

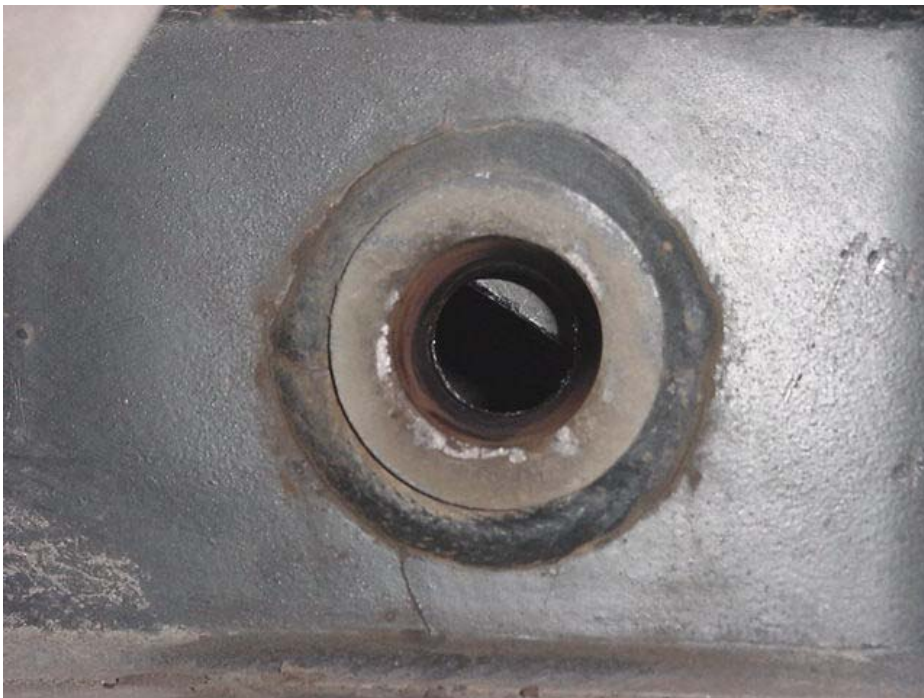
**CRACKED H-BEAM ANCHOR POINT  
(12,743 TEST MILES)**

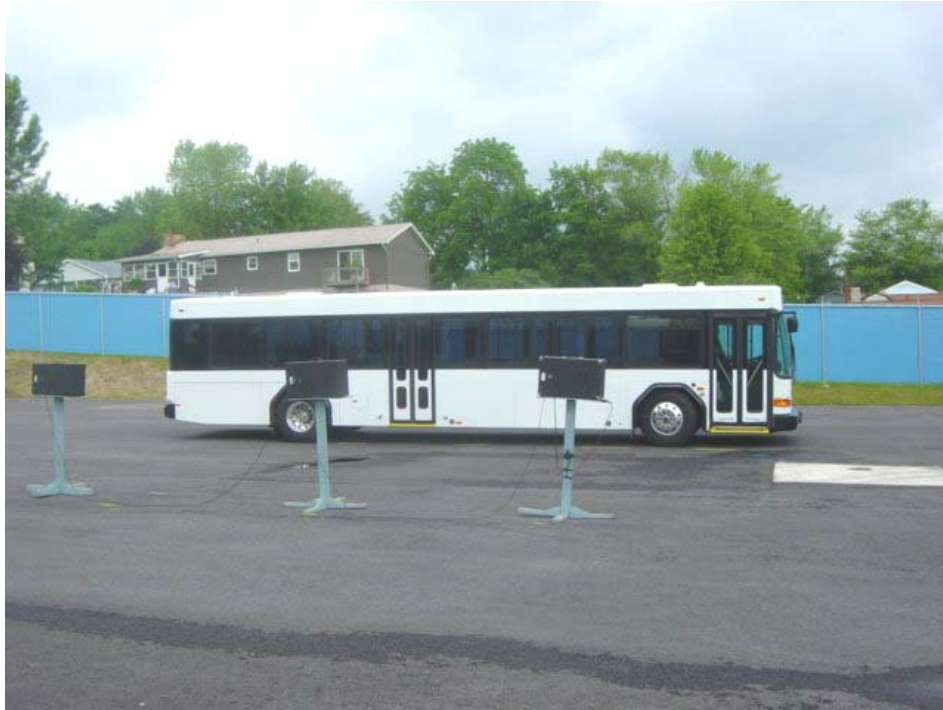
**TEST BUS SET-UP FOR 80 dB(A)  
INTERIOR NOISE TEST**

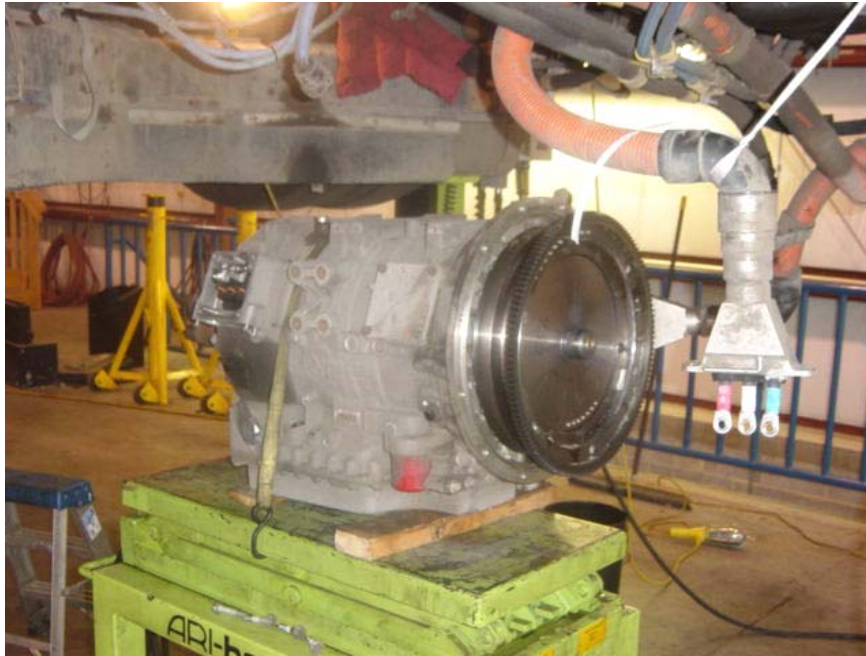
### **TRANSMISSION REMOVAL AND REPLACEMENT (10.00 MAN HOURS)**

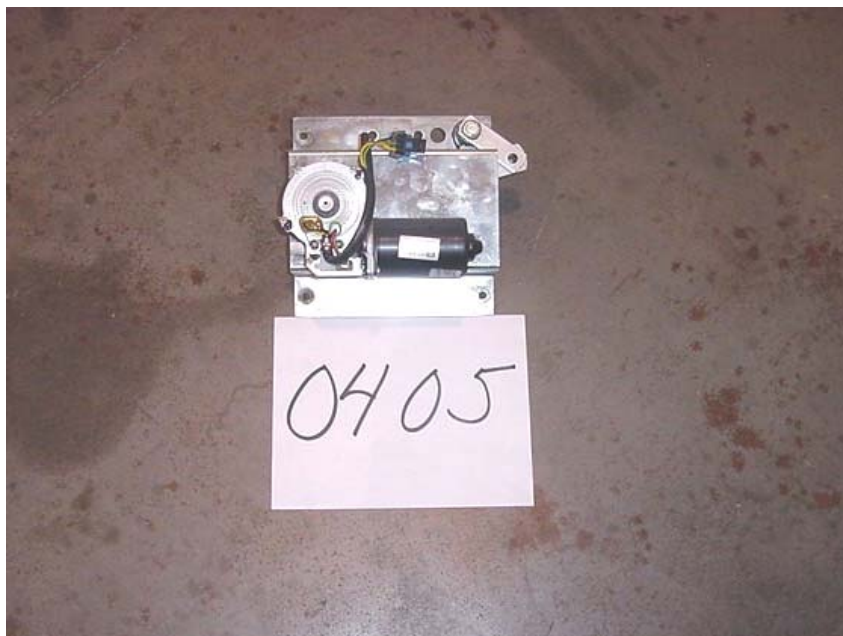
### **WIPER MOTOR REMOVAL AND REPLACEMENT (0.50 MAN HOURS)**

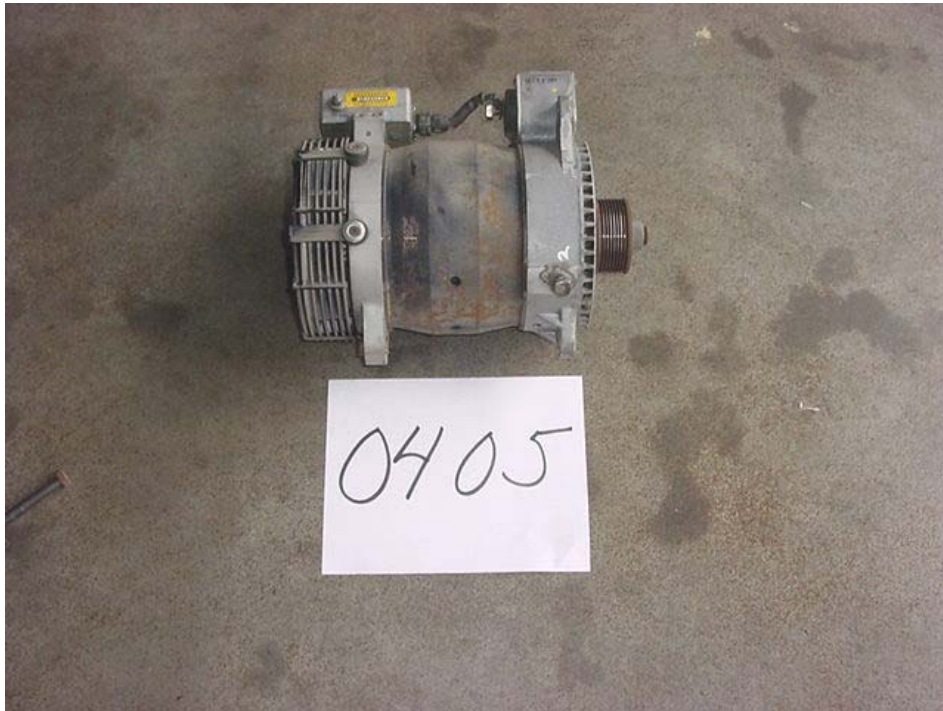
**GENERATOR REMOVAL AND REPLACEMENT  
(1.00 MAN HOURS)**

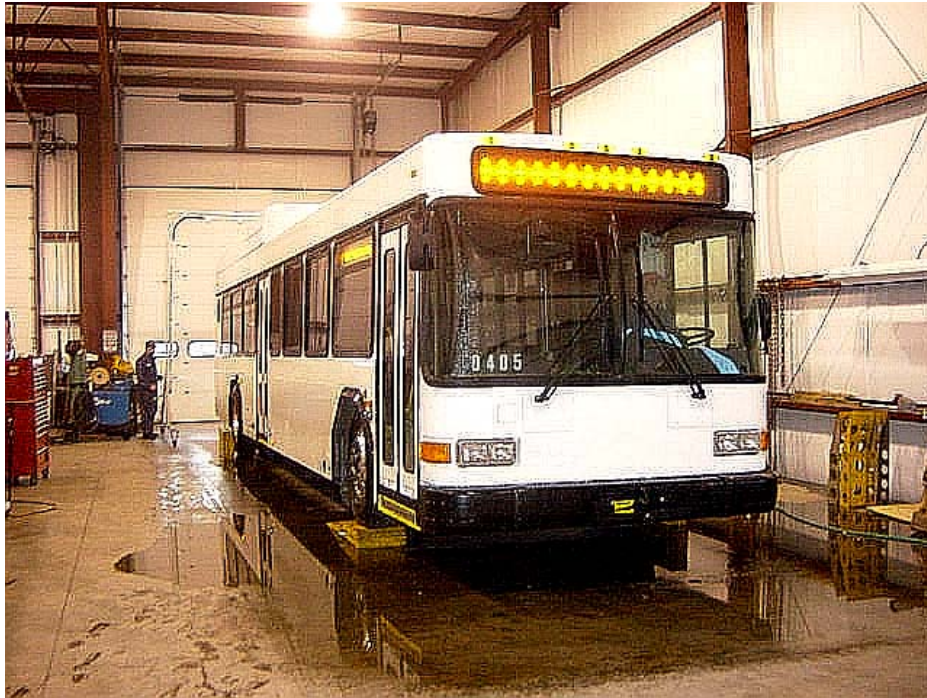
**RIGHT FRONT WHEEL SIX INCHES HIGHER**

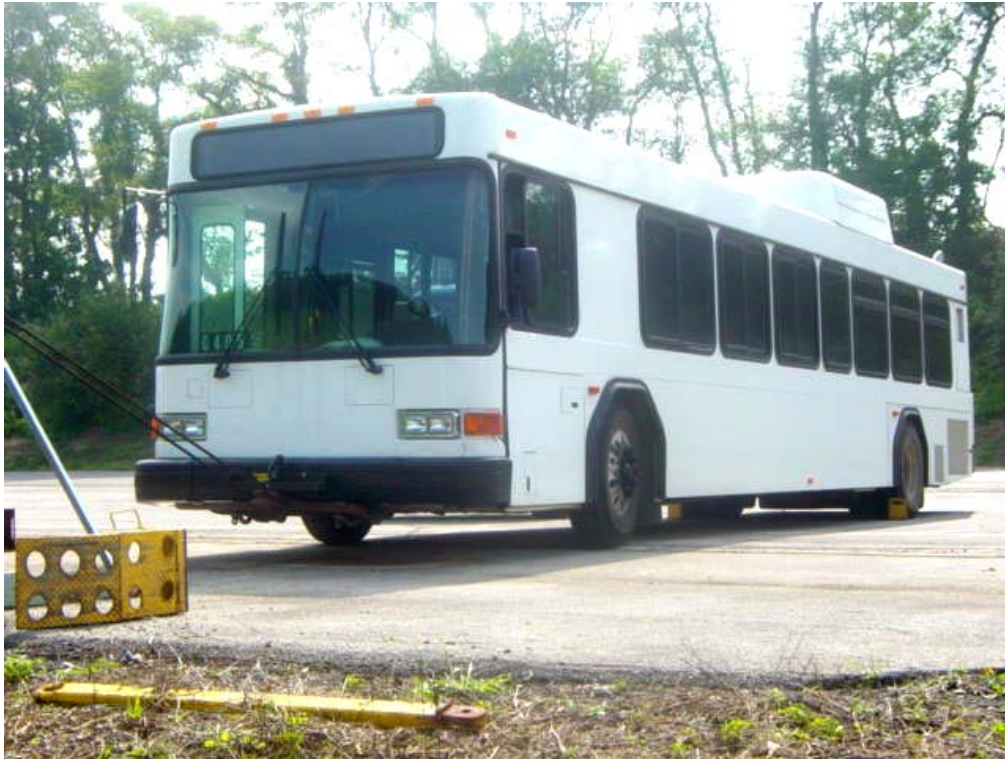
**FRONT 20° UPWARD PULL**

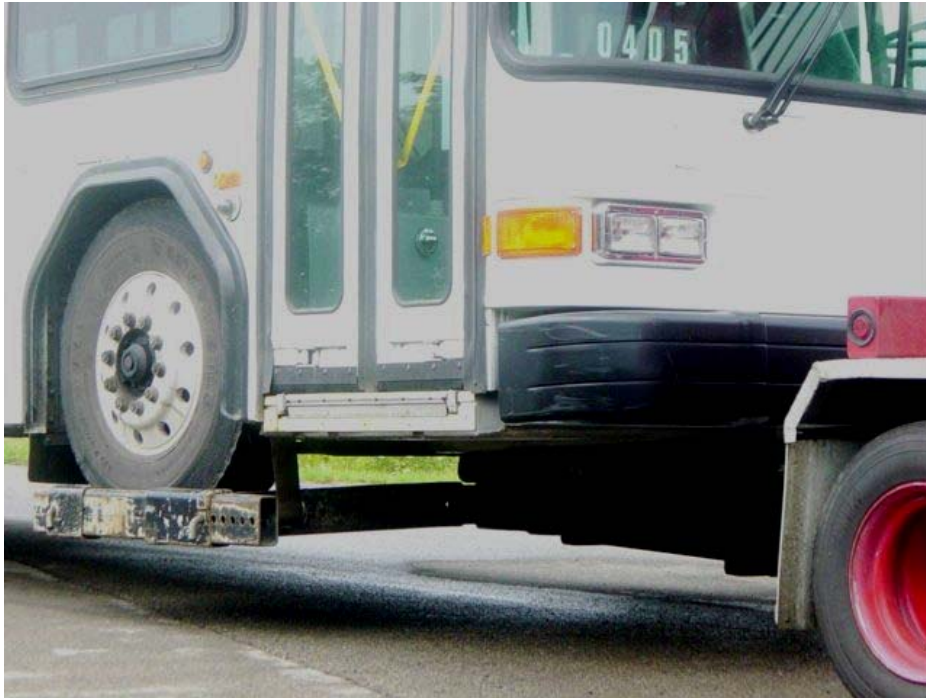
### TOWING INTERFACE

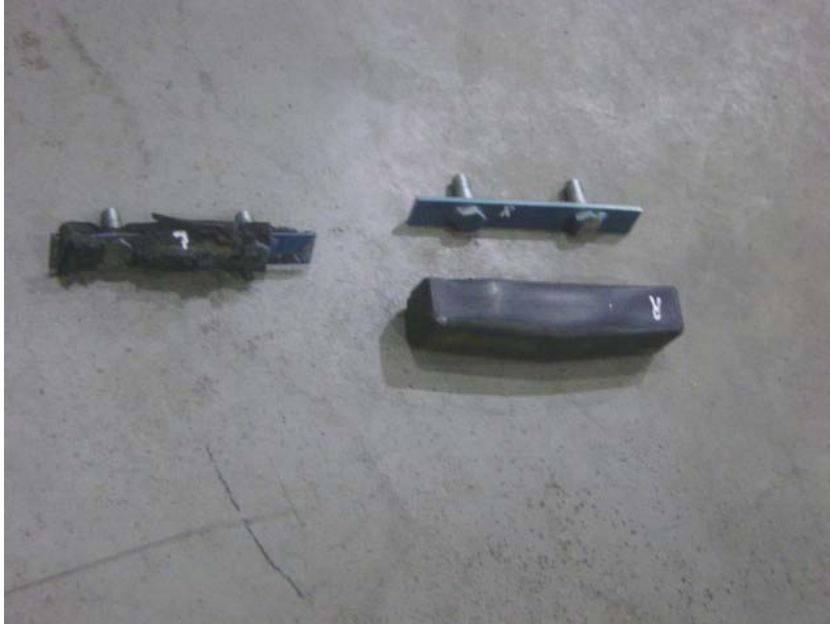
**BROKEN FRONT AXLE BUMP STOPS  
(764 TEST MILES)**

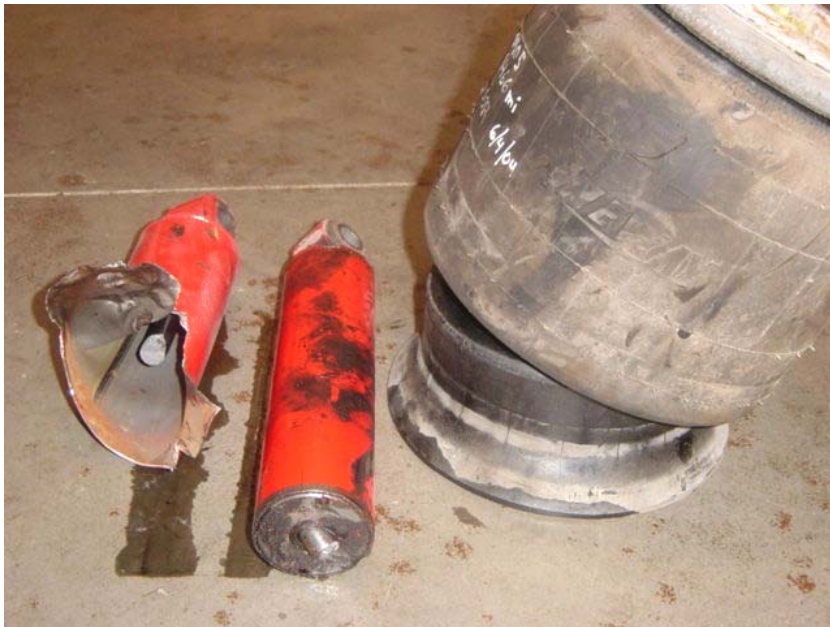
**BROKEN SHOCK PUNCTURED AIR BAG  
(5,571 TEST MILES)**

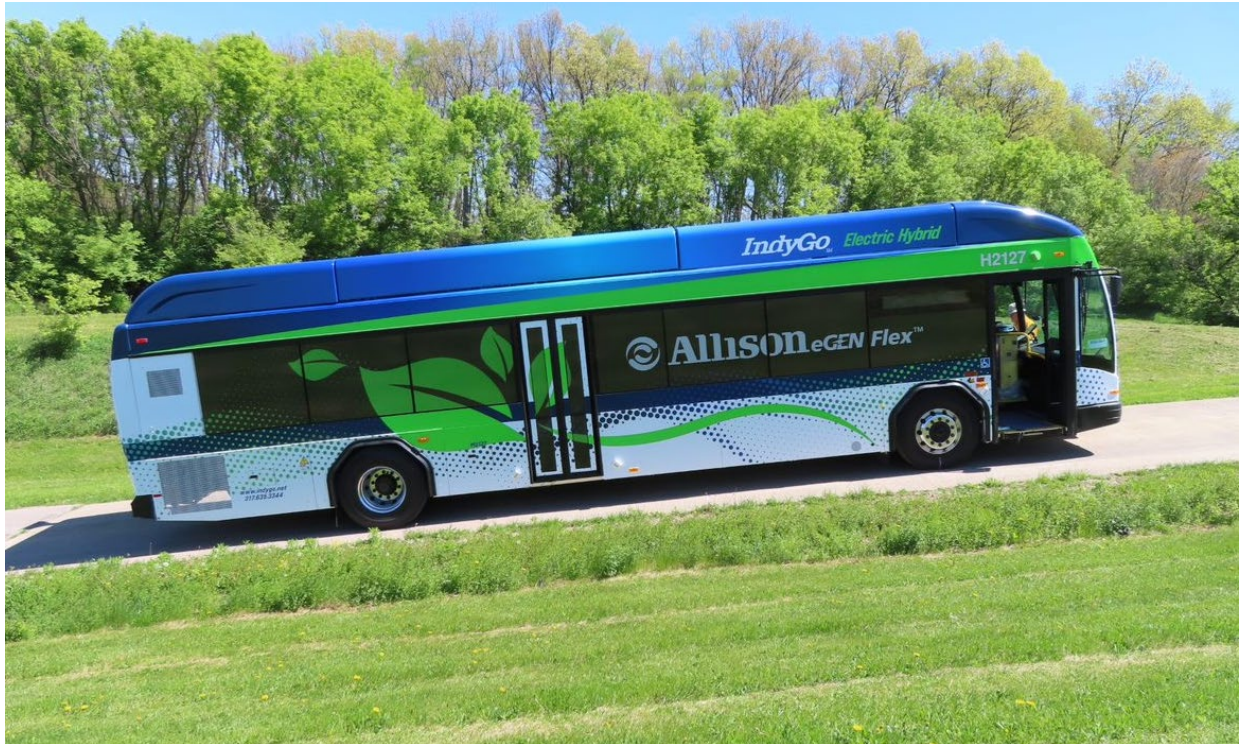
**PARKING BRAKE TEST  
PARKING BRAKE HELD FOR 5 MINUTES IN  
BOTH 20% UP AND 20% DOWN POSITIONS**

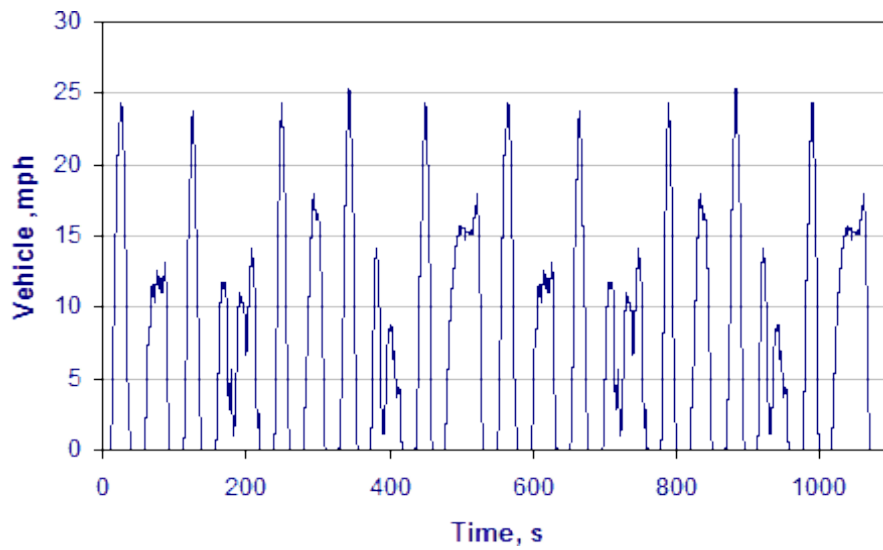
Figure 1. Manhattan Driving Cycle (duration 1089 sec, Maximum speed 25.4 mph, average speed 6.8 mph)

The Multi-Cycle test (MCT) procedure is adopted for this bus. The end of test is determined when the bus cannot maintain 50 miles per hour or earlier, as recommended by the bus manufacturer. The battery system is recharged to full SOC at the end of the test, following procedures specified in SAE J 1634-2017. During the recharge, the DC energy (into the battery system) and the AC energy (into the charger) are recorded. From these data, the average AC energy consumption, the range (miles) and the charger efficiency for each test cycle are reported.

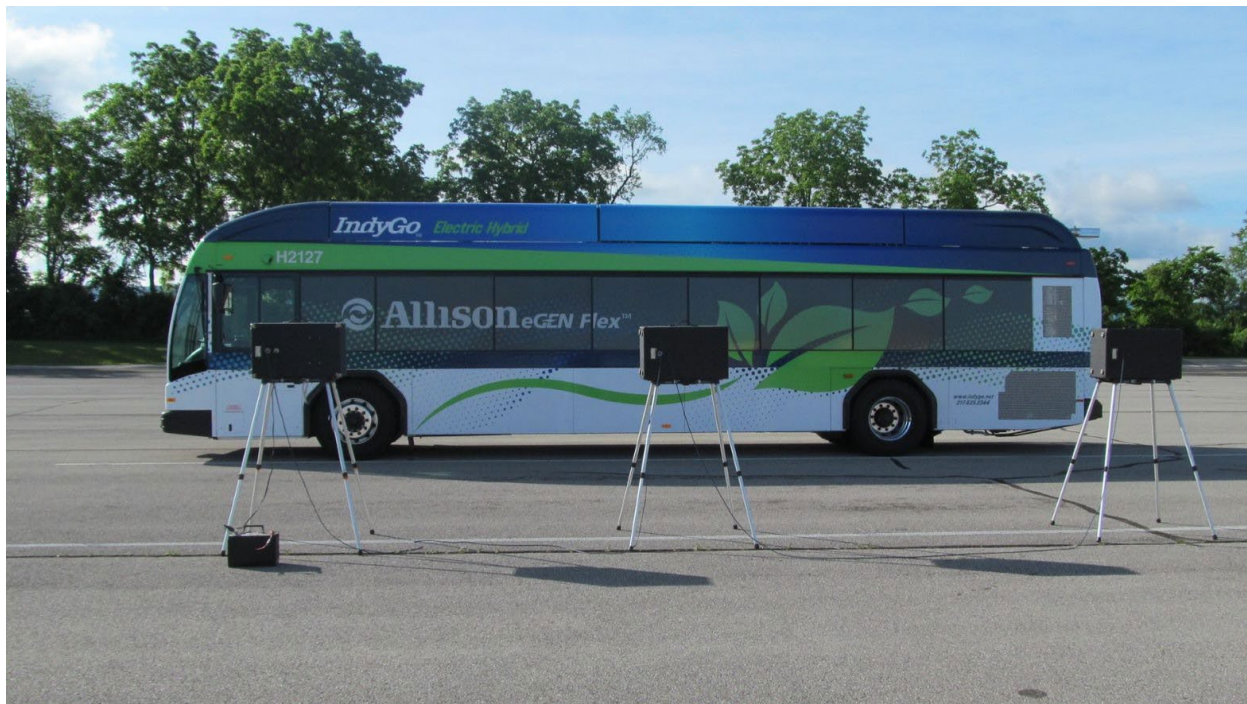
**TEST BUS SET-UP FOR 80 dB(A)  
INTERIOR NOISE TEST**

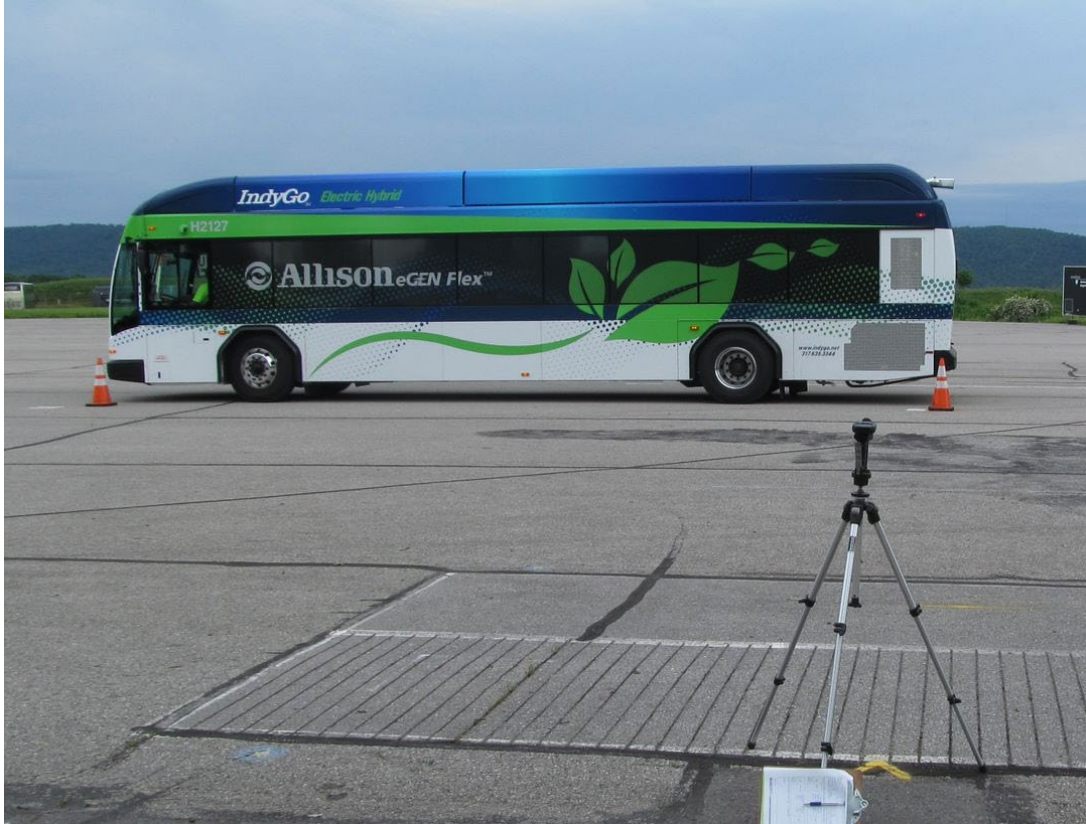
**TEST BUS UNDERGOING EXTERIOR NOISE TESTING**

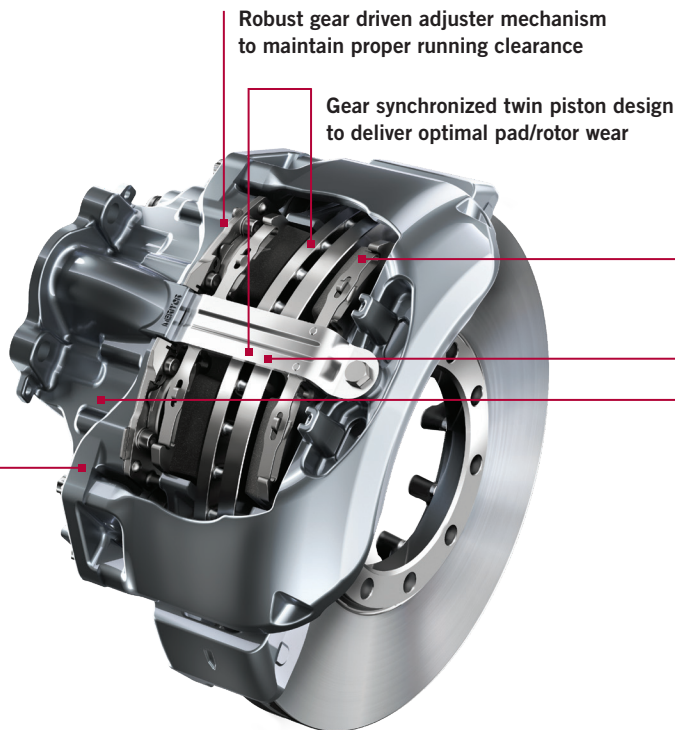
Robust gear driven adjuster mechanism to maintain proper running clearance

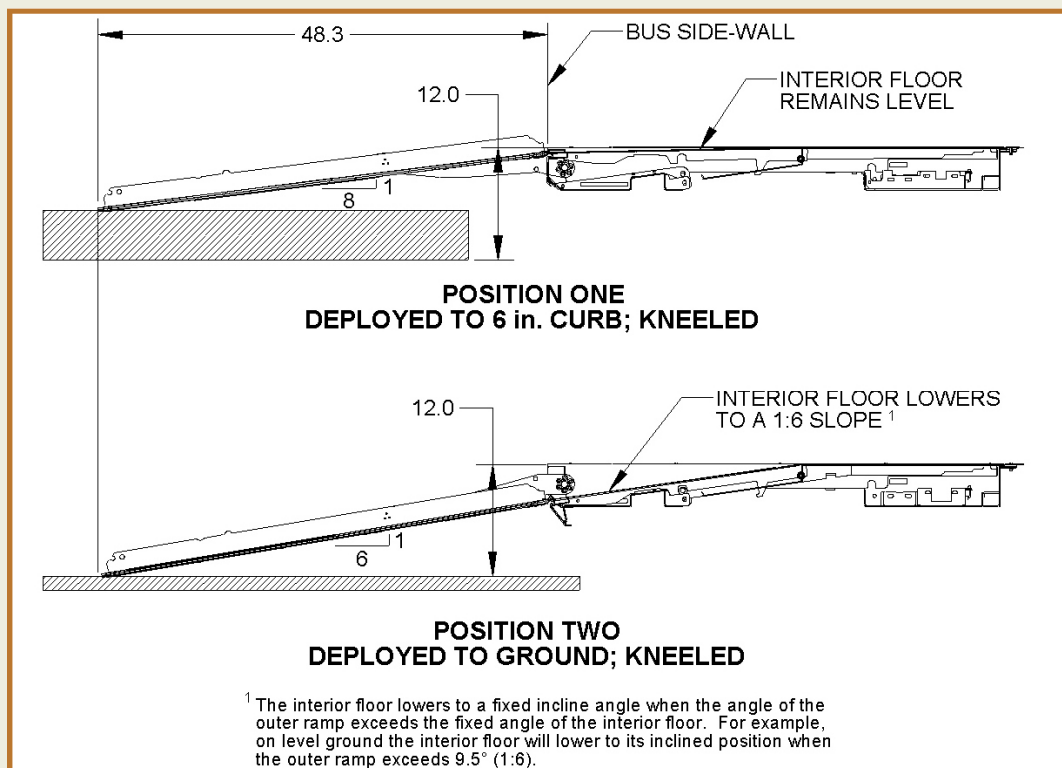
- Mechanism tray components are similar if not the same as our previous LU11 model.
- Rated load capacity is 1,000 pounds.
- Ramp is electrically operated and controlled. No hydraulics required.
- Ramp meets or exceeds ADA and DOT requirements.
- Self-contained module. Unit can be changed out in less than 30 minutes. No ramp components located outside of the ramp mechanism.
- Tensioned controlled to prevent “free falling” of ramp platform in any direction.
- Ramp comprises an internal “rising floor” for easier passenger transition to/from the bus aisle. No depressed pockets to negotiate.
- The LU18 includes an object detection feature. As the unit is electrically deployed or stowed, should the ramp encounter an obstruction, the drive motor is disabled and ramp motion stops. Simply releasing the operator switch will automatically reset functionality.

- The LU18 ramp incorporates soft-touchdown technology. As the unit is electrically deployed, the ramp decelerates before it contacts the sidewalk or roadway.

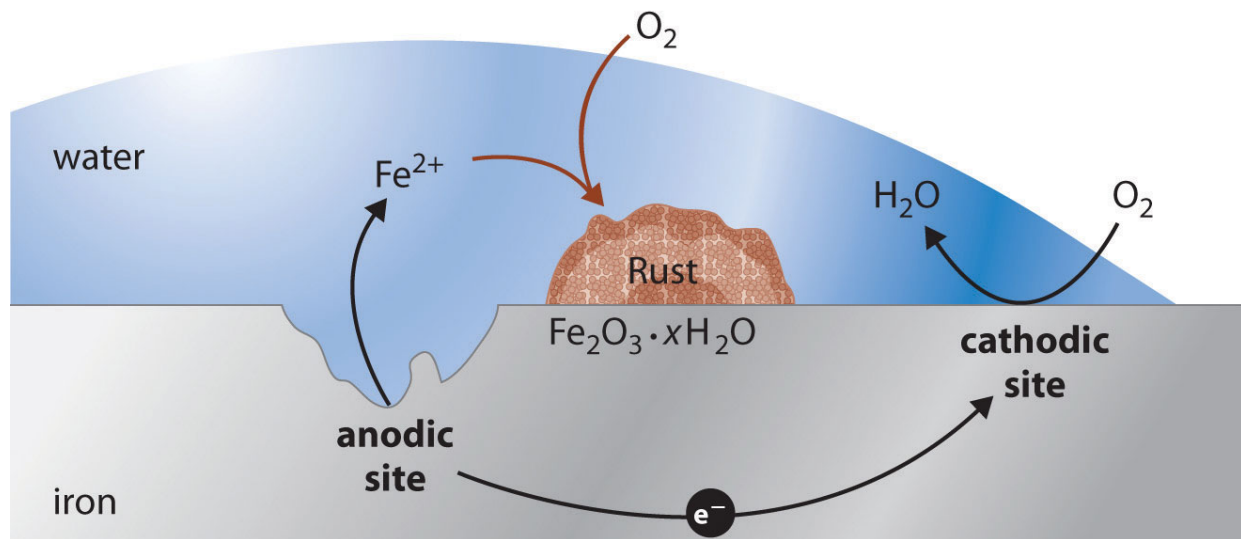
The figure below describes the reaction of ordinary carbon steel with oxygen ( $O_2$ ) that is present in the atmosphere. The anodic (active) areas may initially be remnants of mill scale, inclusions, discontinuities, or possibly the effect of pollutant on the oxide film. Electrons migrate away from the anodic sites, producing positively charged iron molecules. Oxygen from the water combines with iron in the steel to form iron oxide ( $Fe_2O_3$ ), known more commonly as rust.

Typical carbon steel is approximately 98% iron (Fe). Iron oxide on carbon steel does not form a continuous layer on the steel because the iron oxide molecule has a larger volume than the underlying iron atoms. The iron oxide scale is essentially porous in nature, which allows for continued attack of the steel substrate, regardless of the thickness of the overall oxide layer.

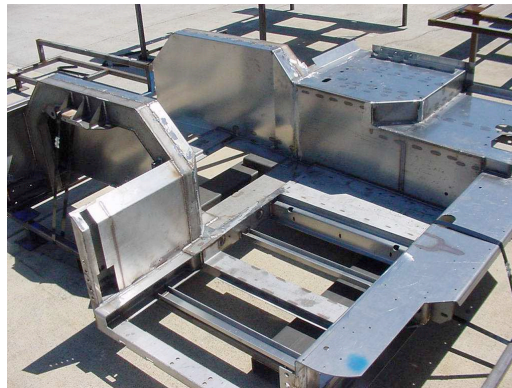
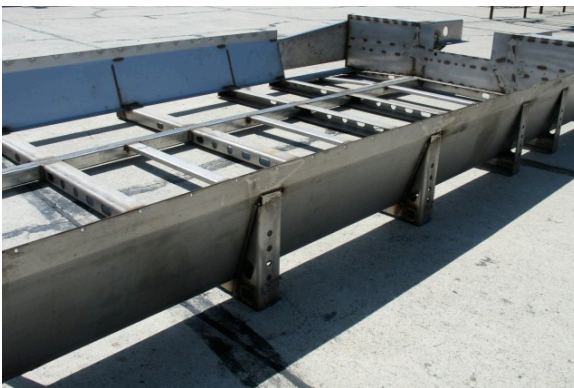
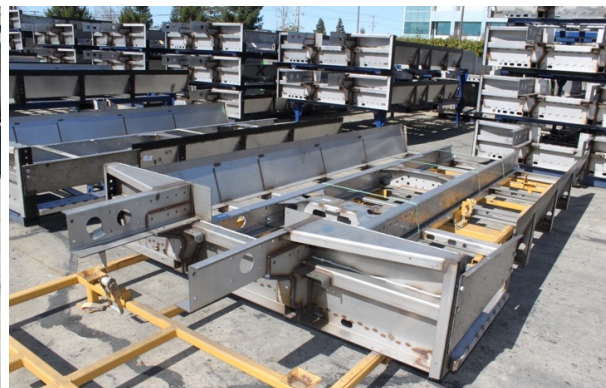
The front stainless steel module design also allows for better ADA accessibility. The enlarged entrance area leads to a wide aisle way between the front wheel wells. It actually provides for a 36" width in that area and allows generous room for maneuvering the larger mobility devices.

Top: Front section of the stainless-steel chassis. Bottom: Center section of the stainless-steel chassis.

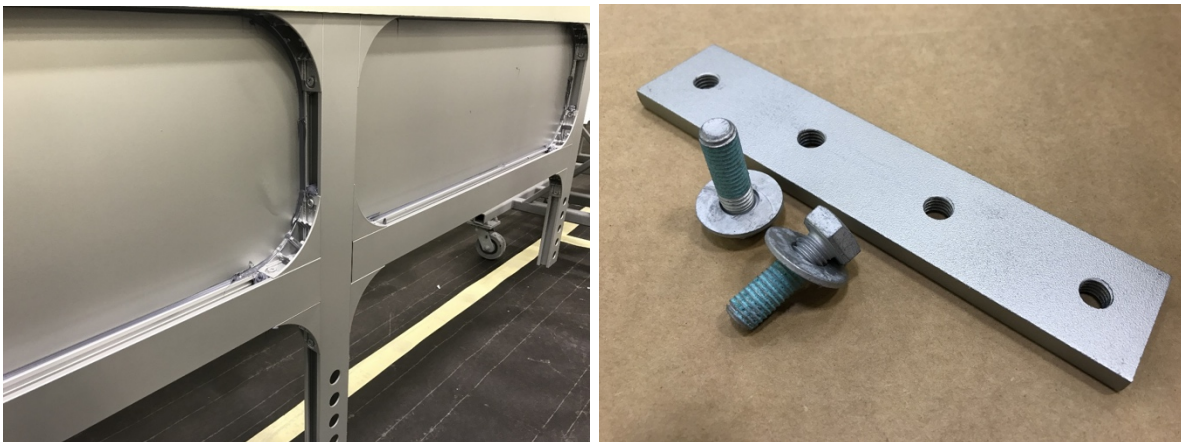
There is no welding on the GILLIG Low Floor body structure.

Left: Coated Body Structure. Right: Geomet-Coated Body Attachment Hardware.

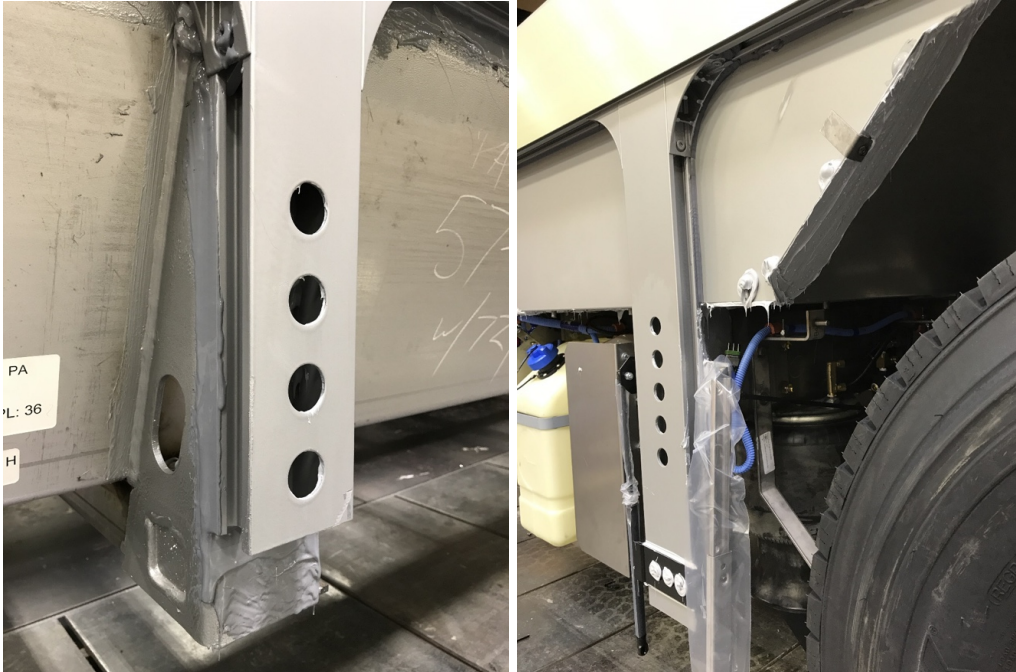
Before the body is connected to the chassis with Geomet hardware, a specially formulated hybrid epoxy/sealant coating is applied to the mating surfaces to add mechanical strength and seal out corrosive elements. After the connection is made, all joints are redundantly sealed.

Left: Protected & sealed body/chassis connection. Right: Sealed wheel well and stress panel arch.

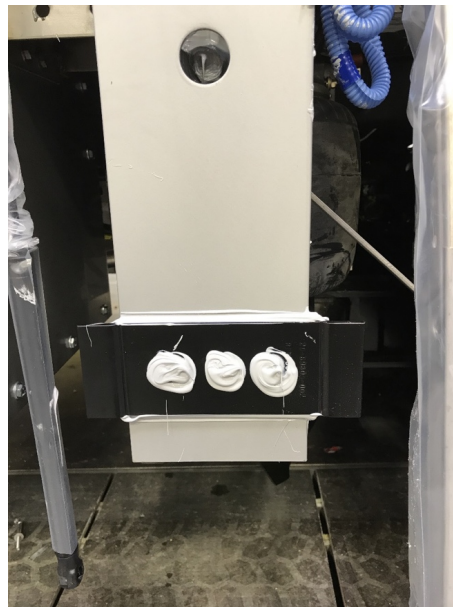
The brackets are installed using aircraft-grade structural aluminum rivets, avoiding any dissimilar metal contact.

Sealed & powder coated aluminum skirt panel bracket

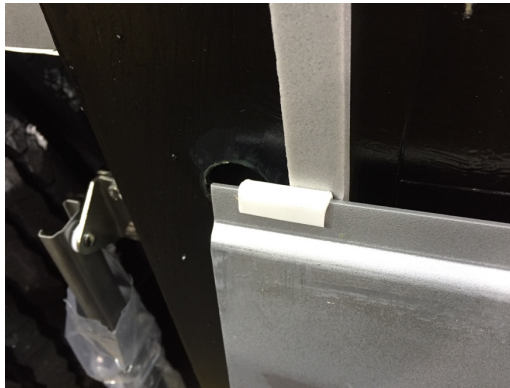
Non-hinged skirt panels have a 2-in. (5-cm) piece of polyurethane foam tape every 12 in. (30 cm) before being inserted into the mid-rail channel. The tape eliminates road rattle and allows air flow inside the mid-rail channel which eliminates moisture saturation. The bottom edge of the skirt panel is bolted to the skirt panel brackets using Dacromet and/or Geomet coated fasteners.

Tape applied to top edge of coated skirt panel

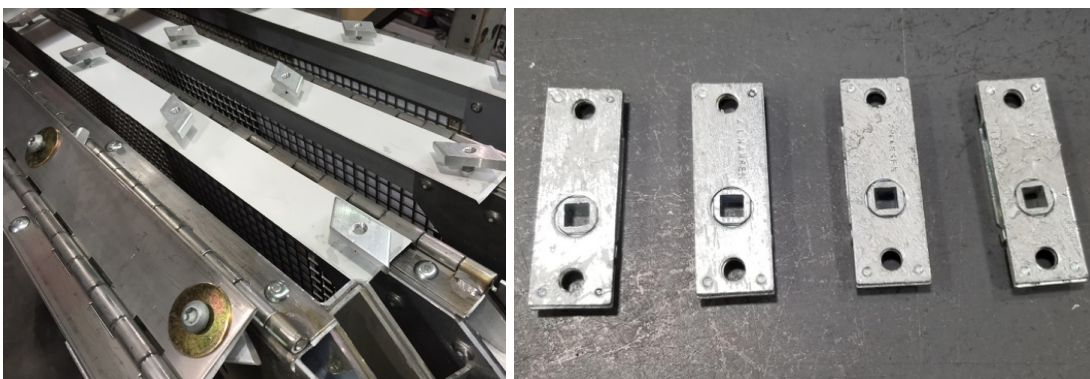
Hinged skirt panels are attached to the body with stainless steel hinges. The surface of the panel where it is attached to the hinge is coated with epoxy primer. Additionally, a continuous strip of high-dielectric-strength isolating tape is bonded between the hinge and the body attachment for added corrosion protection. These panels are locked in place with 5/16-in. (0.8-cm) stainless square key locks. The back of the stainless-steel lock is coated before being riveted to the panel with aluminum rivets. The body mounted lock catch is also treated.

Left: Isolating tape applied over primed hinged panels.  
Right: Stainless steel square key locks with pre-applied protective coating.

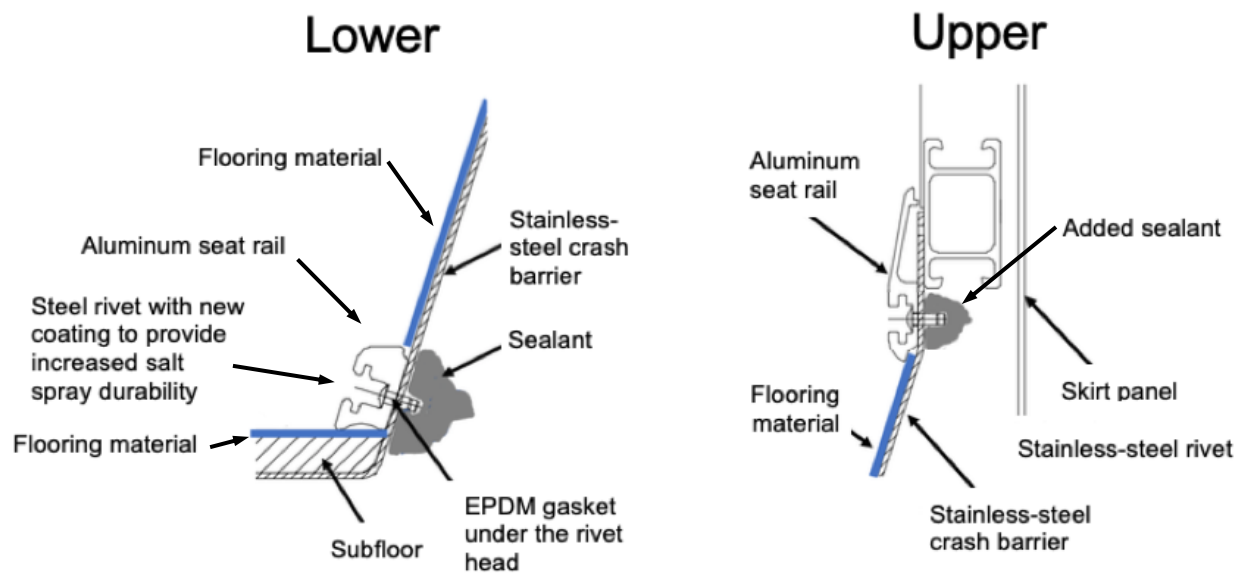
The seat rails are secured to the chassis with rivets. The upper seat rail is mounted to the chassis with a stainless-steel rivet. The backside of the rivet is then sealed with Manus 75AM. The lower seat rail rivet is the same rivet except the coating is zinc-nickel plated that is rated at 2,000 hours of salt-spray testing before red rust is visible. The rivet also has a washer under the head to prevent water intrusion from entering the joint from the inside of the bus.

GILLIG also provides a barrier between the lower seat rail and the crash barrier. A galvanic corrosion coating is applied to the chassis crash barrier prior to the installation of the lower seat rail. The chassis crash barrier is cleaned and primed with an epoxy coating to eliminate the direct contact between the dissimilar metals providing protection against galvanic corrosion.
