U.S. ARMY ABERDEEN TEST CENTER
ABERDEEN PROVING GROUND, MARYLAND 21005-5059
TEST RECORD

ATEC Project No.: 2007-DT-ATC-AFSPT-D2979
Test Type and Title: Armored Vehicle Roll-Over
Test

Test Record No.: AD-V-25-07

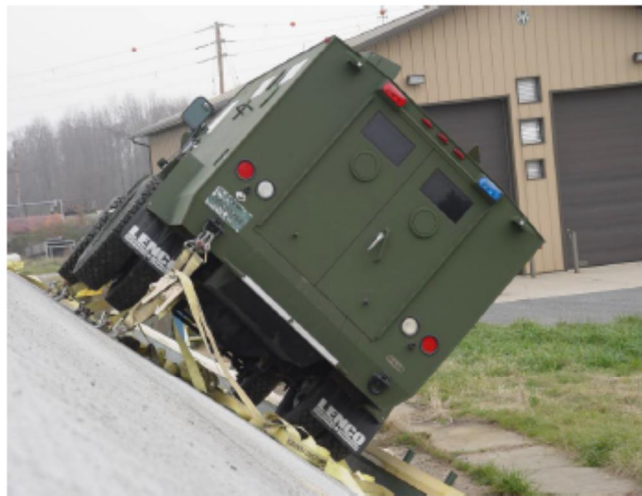
Figure 6. BearCat on the Tilt Table at rollover threshold.

g. Tilt Table. The static rollover threshold of the BearCat at GCW was measured using the ATC Tilt Table. Maximum side slope angle (accuracy ± 0.2 degree of reading) and simulated lateral acceleration (accuracy ± 0.01 degree of reading) were determined with both the left and right side of the vehicle positioned upslope. Static rollover results are presented in Table 7. A photograph of the BearCat on the Tilt Table is shown in Figure 6.
